NL INDUSTRIES/TARACORP SUPERFUND SITE GROUP

**Re: NL Industries/Taracorp Superfund Site; Granite City, Illinois
Second 2017 Semi-Annual Operation and Maintenance Inspection (December 2017)**

**NL Industries/Taracorp Superfund Site
Inspection Log - Operation and Maintenance**

Inspection Date: 12/4/2017
Weather: Cloudy, windy, 55 F - 60 F

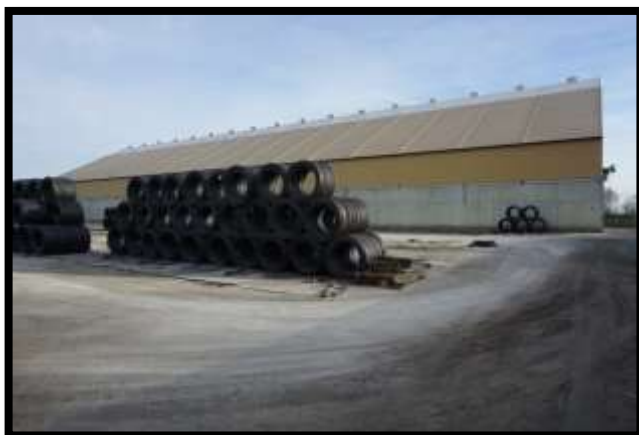
Photograph 1: Beelman storage area/warehouse.

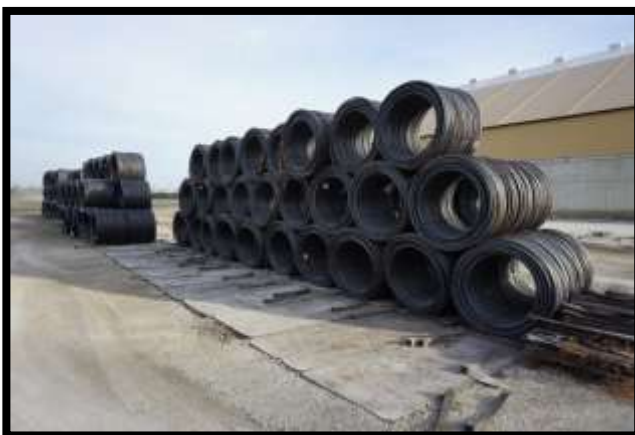
Photograph 2: Beelman storage area/warehouse.

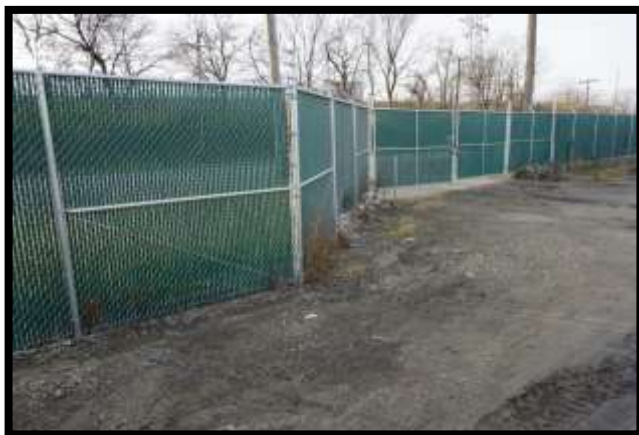
Photograph 3: Slough Road, inside of fence.

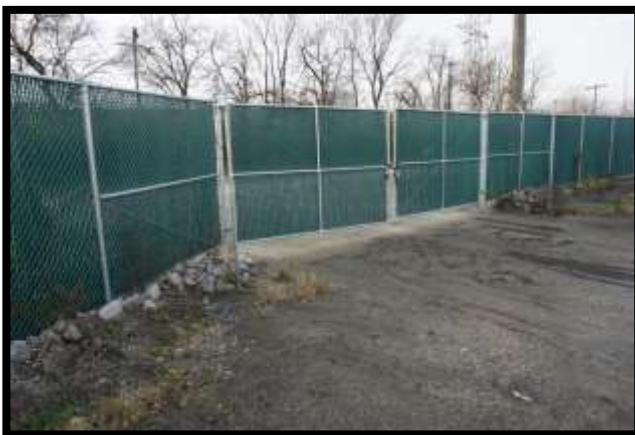
Photograph 4: Slough Road, inside of fence.

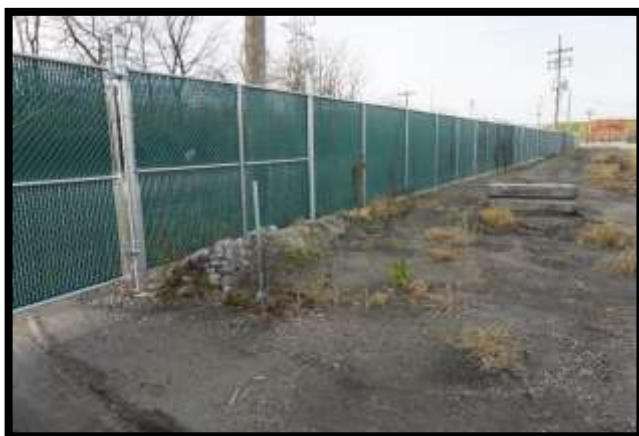
Photograph 5: Slough Road, inside of fence.

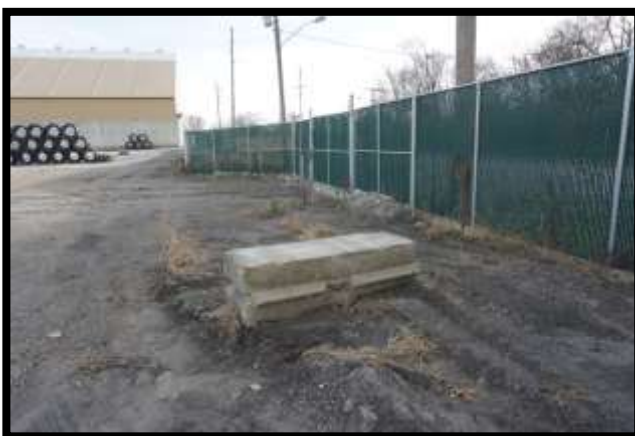
Photograph 6: Slough Road, inside of fence.

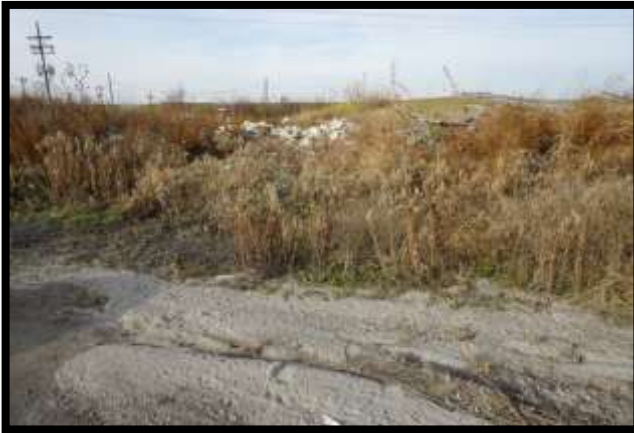
Photograph 7: Slough Road, concrete debris pile.

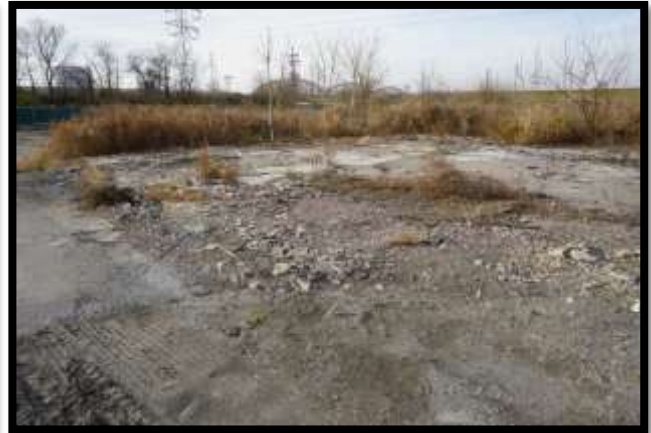
Photograph 8: Slough Road, concrete debris, foundation of former Robin's Nest Lounge.

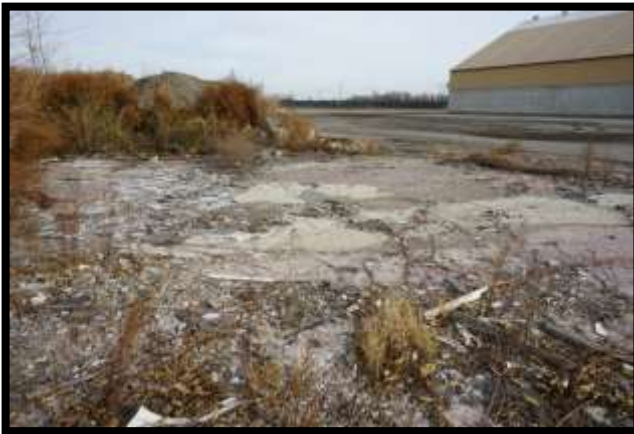
Photograph 9: Slough Road, concrete debris, foundation of former Robin's Nest Lounge.

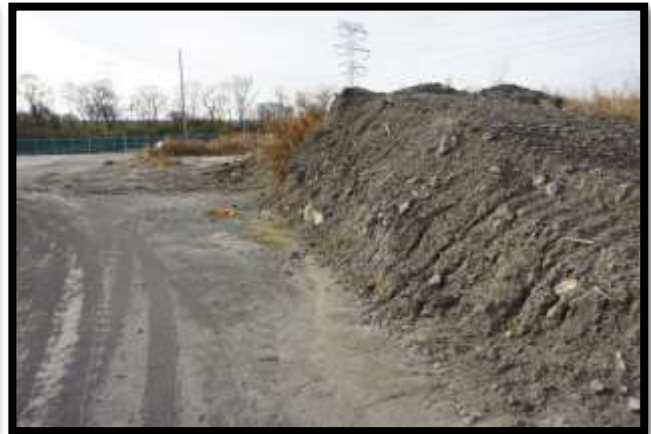
Photograph 10: Slough Road, roadway.

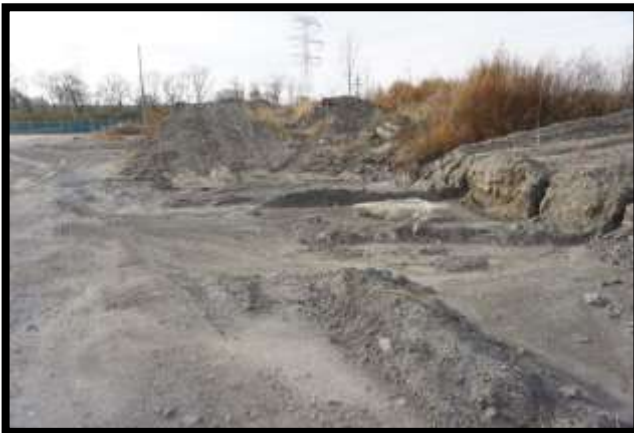
Photograph 11: Slough Road, roadway.

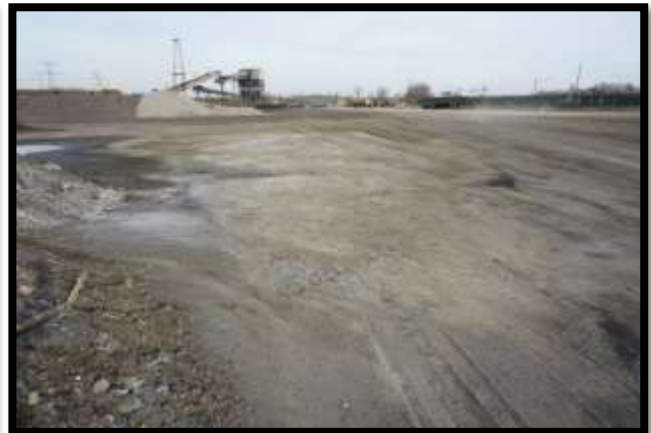
Photograph 12: Slough Road, roadway.

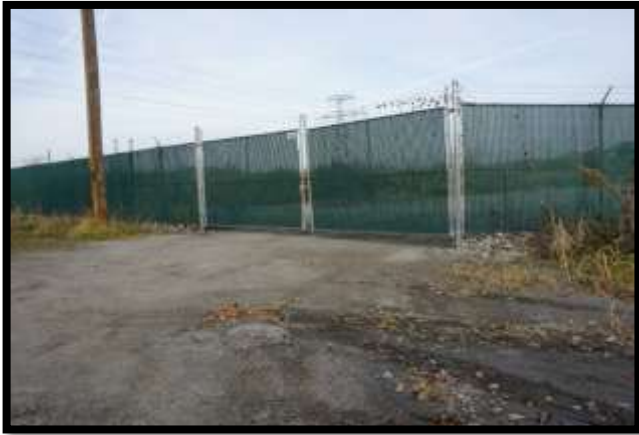
Photograph 13: Slough Road, outside of fence along Bremen Street.

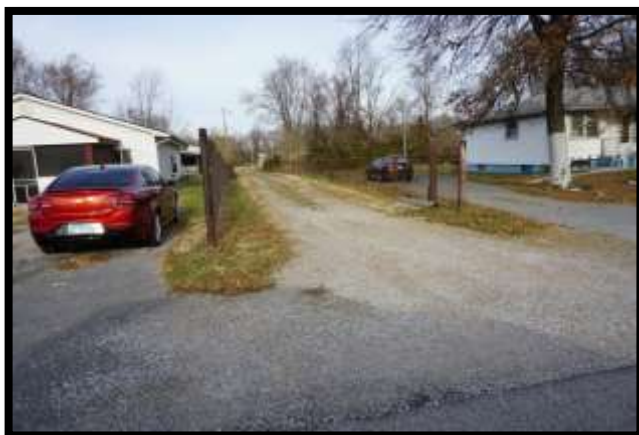
Photograph 1: Watson Alley, gravel area.

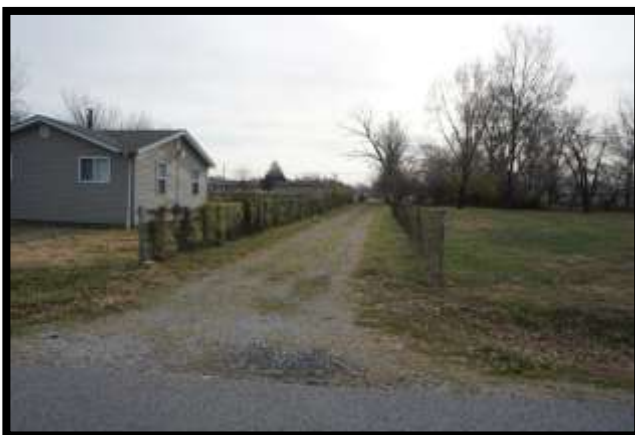
Photograph 2: Watson Alley, gravel area.

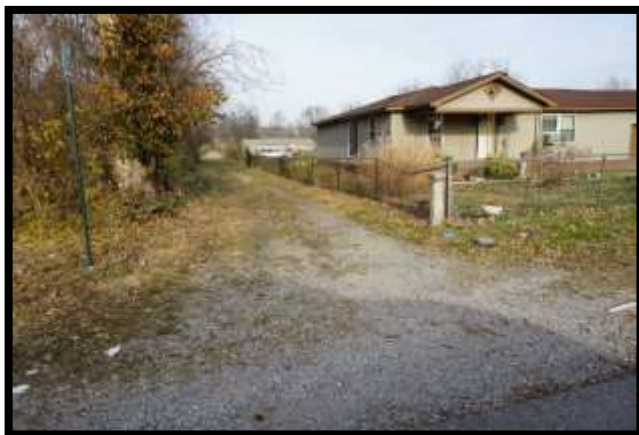
Photograph 3: Watson Alley, gravel area.

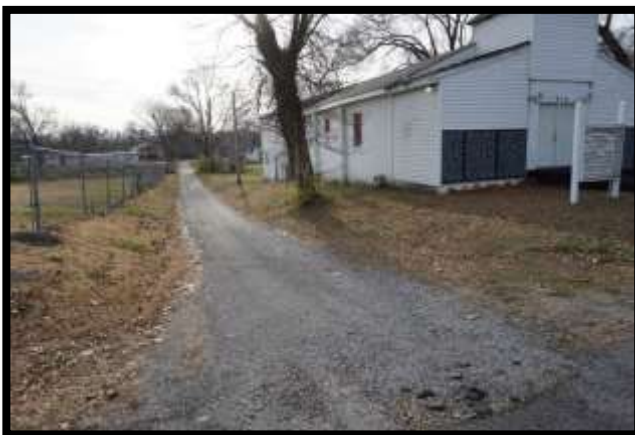
- The paved portion of Watson Alley in Eagle Park Acres (shown on Figure 2 and the photographs in Attachment 2) was inspected and noted to be in good condition.

Photograph 4: Watson Alley, paved area (view from Harrison Street).

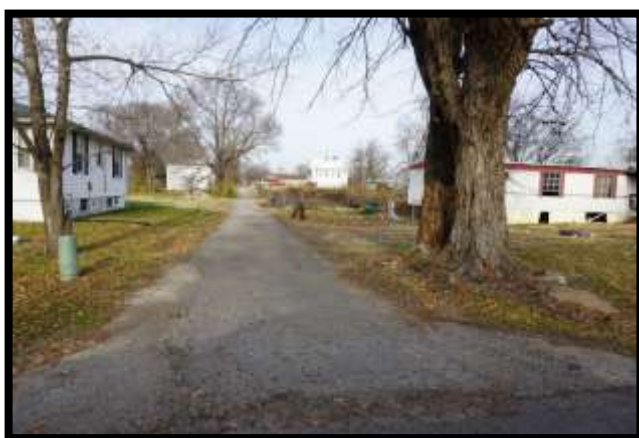
Photograph 5: Watson Alley, paved area (view from Watson Street).

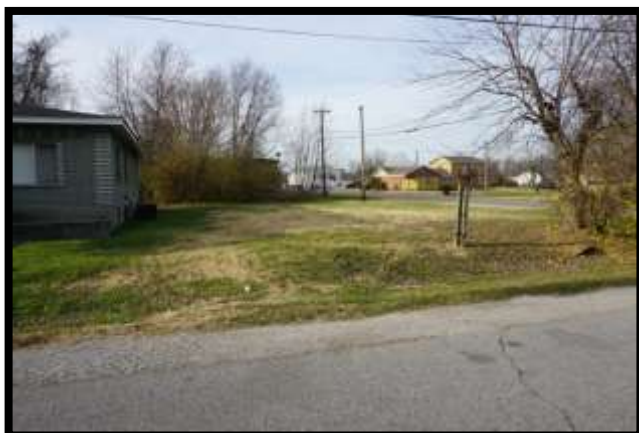
Photograph 1: **non-responsive** property.

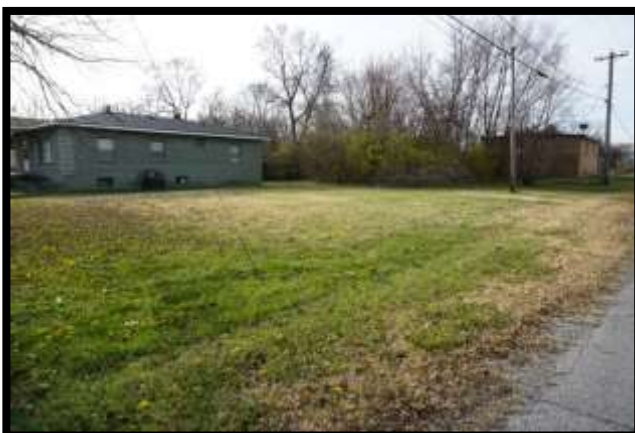
Photograph 2: **non-responsive** property.

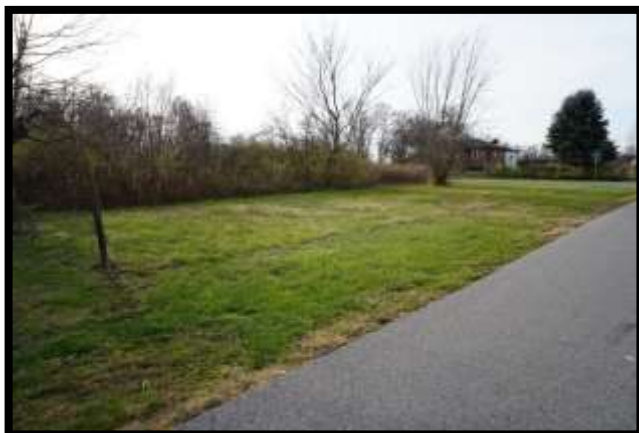
Photograph 3: **non-responsive** property.

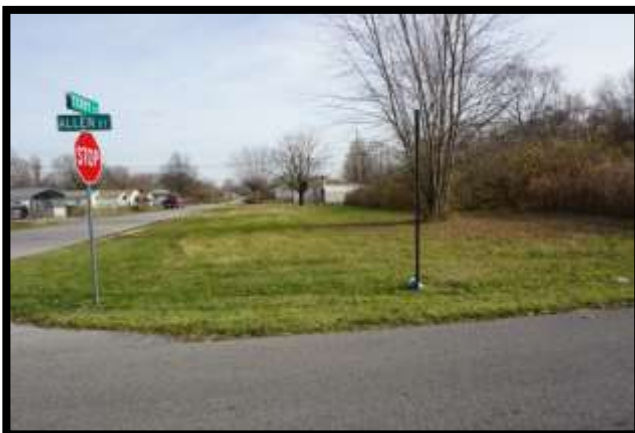
Photograph 4: **non-responsive** property.

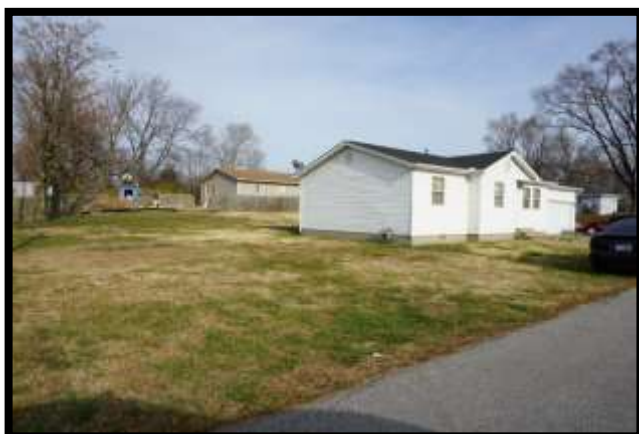
Photograph 5: **non-responsive** property (now known as **non-responsive** property).

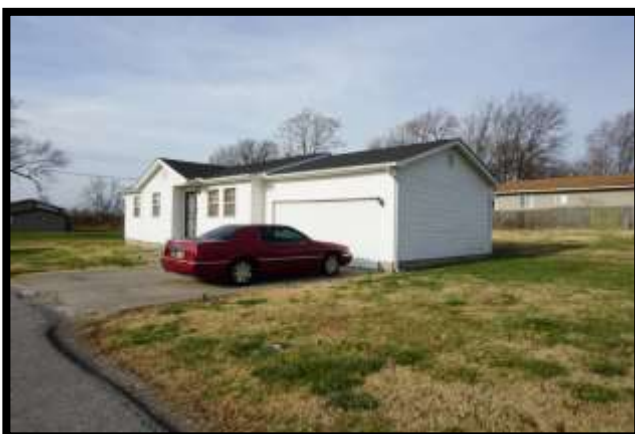
Photograph 6: **non-responsive** property (now known as **non-responsive** property).

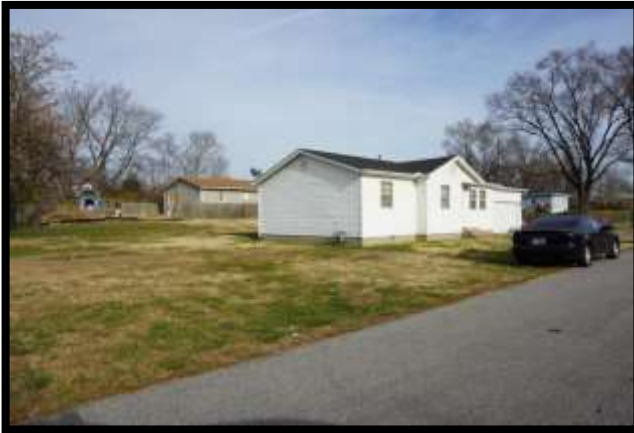
Photograph 7: non-responsive (now known as non-responsive property).

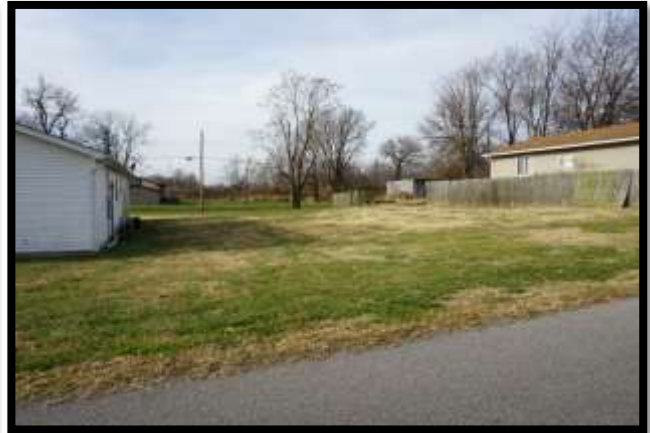
Photograph 8: non-responsive property (now known as non-responsive property).

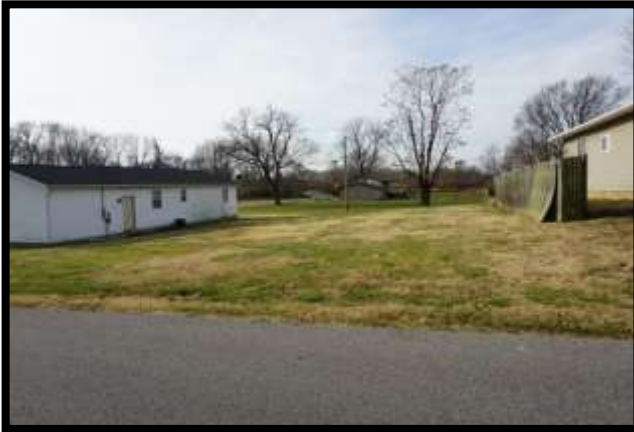
Photograph 9: non-responsive property (now known as non-responsive Street property).

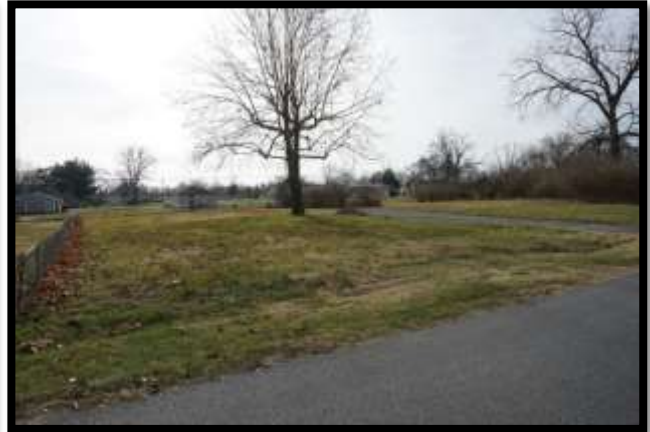
Photograph 10: non-responsive property.

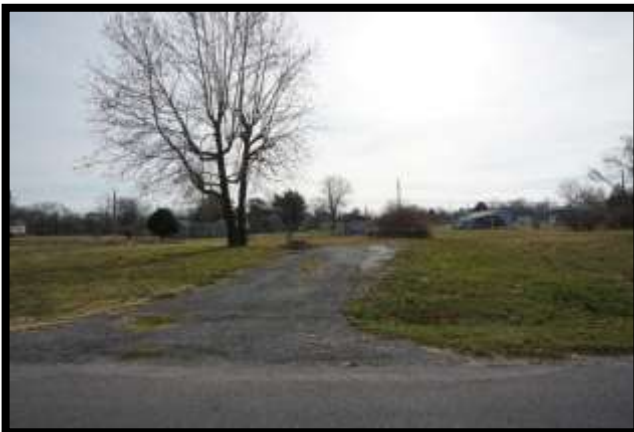
Photograph 11: non-responsive property.

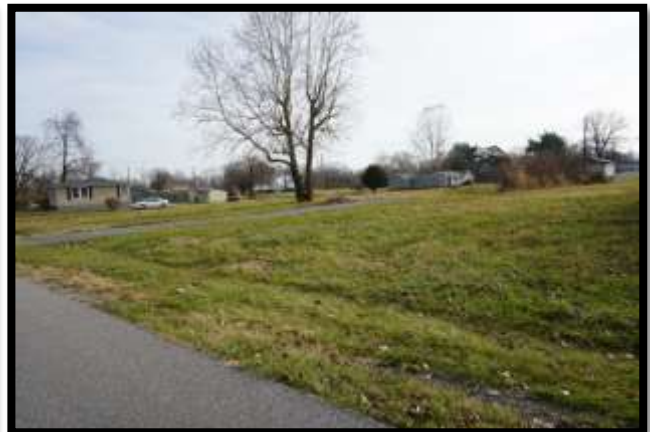
Photograph 12: non-responsive property.

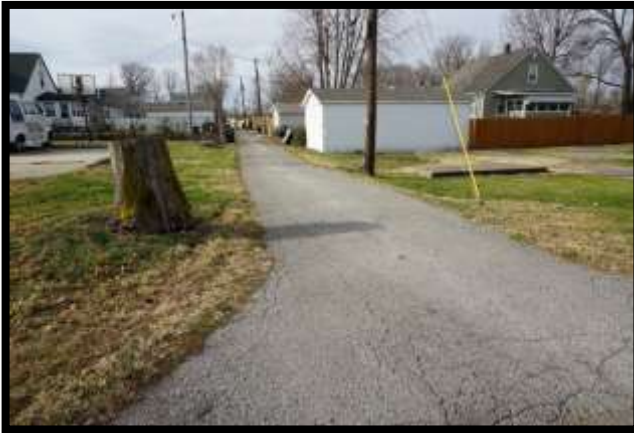
Photograph 1: Alley at McKinley Street near Broadway.

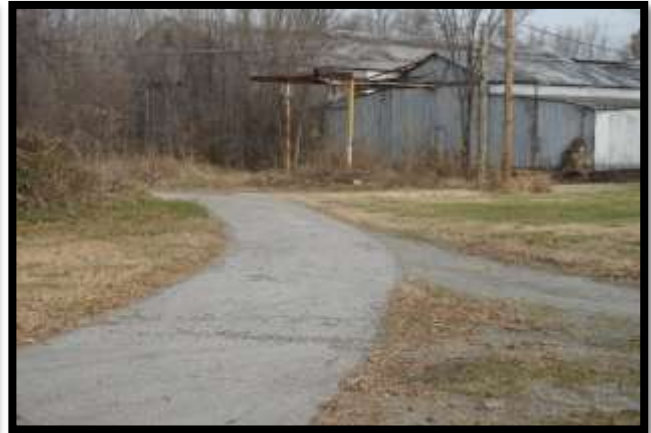
Photograph 2: Alley at McKinley Street and Brown Street (view north).

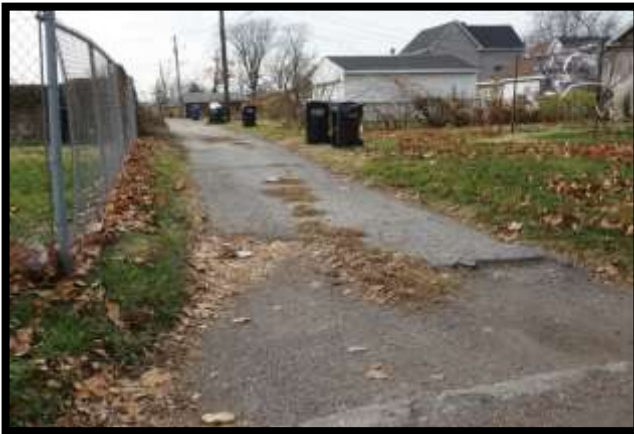
Photograph 3: Alley between Robin Street and Oriole Street (view south).

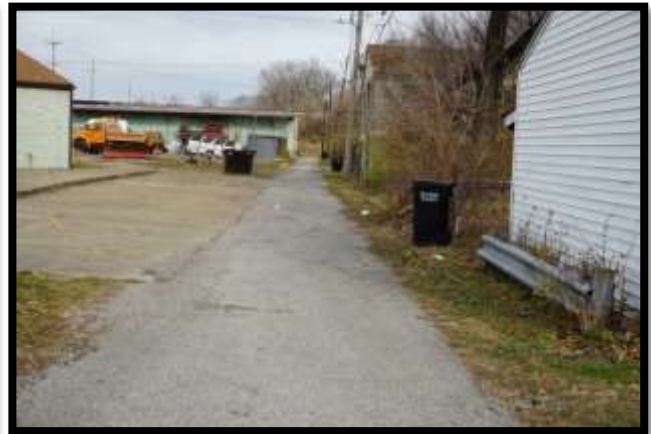
Photograph 4: Alley between Oriole Street and Klein Avenue (view north).

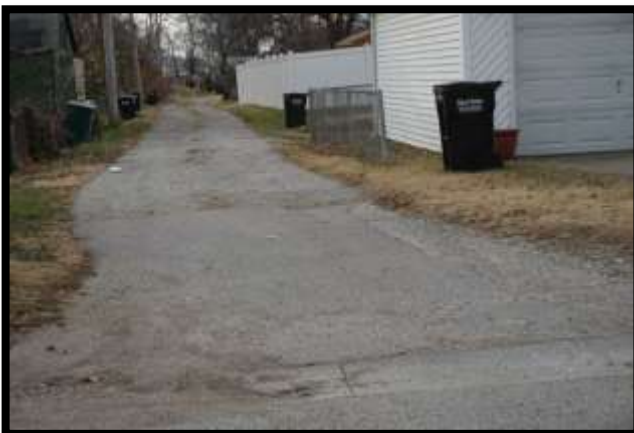
Photograph 5: Alley (gravel) between Oriole Street and Klein Avenue (view south).

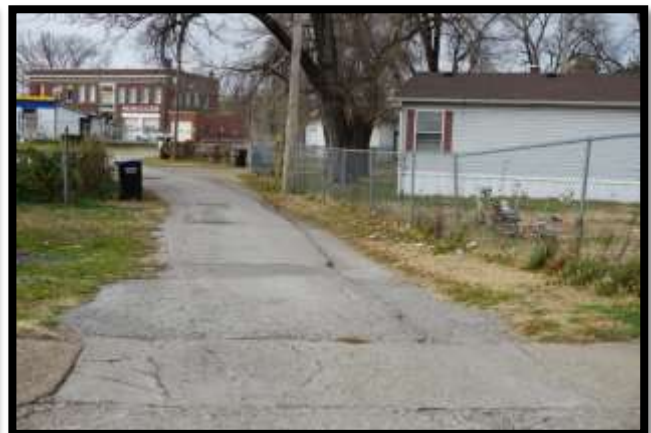
Photograph 6: Alley between Broadway and Oriole Street (view southwest).

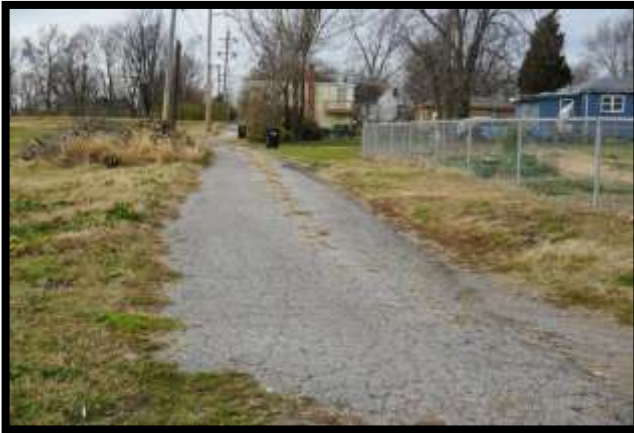
Photograph 7: Alley between Fillmore Avenue and Jefferson Street.

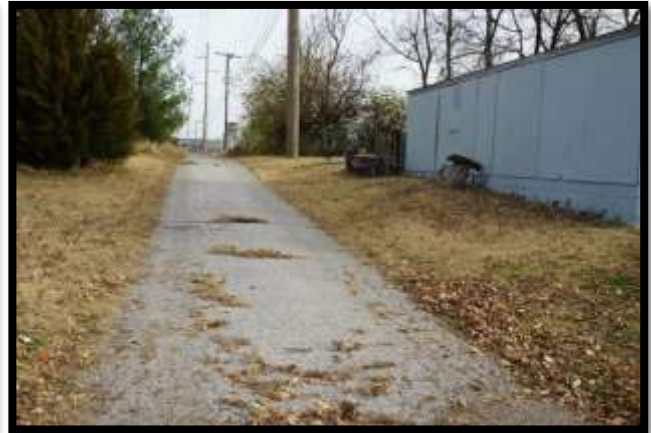
Photograph 8: Alley between Jefferson Street and Fillmore Street ([REDACTED]).

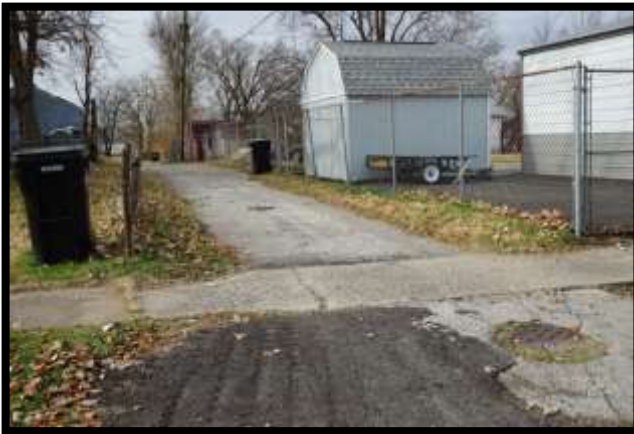
- Alleys in Venice that were paved during remedial activities were inspected and noted to be in generally good condition, with some minor cracking and deterioration observed in some areas, with no battery case chips visible. The Venice alleys are shown on Figure 1 and are identified on the photographs in Attachment 4. Previous inspections have confirmed that the local municipality is continuing to repair and repave alleys, as necessary (Attachment 4, photograph 9).

Photograph 9: Alley between Jefferson Street and Washington Street (view [REDACTED]).

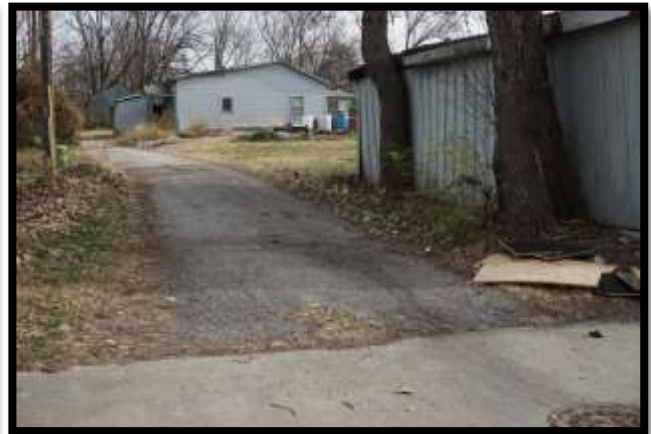
Photograph 10: Alley between Jefferson Street and Washington Street (view non-[REDACTED] non-[REDACTED]).

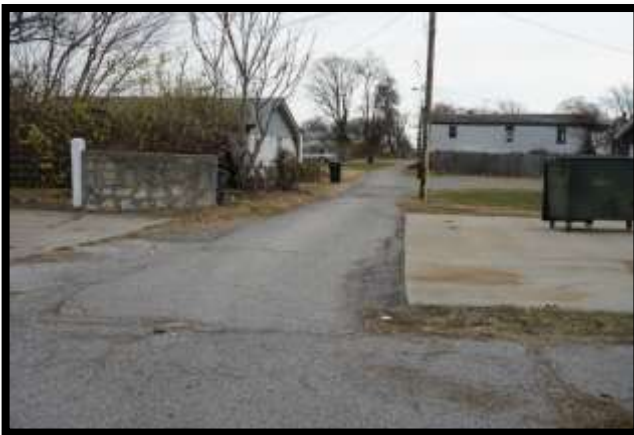
Photograph 11: Alley between Bissell Street and Market Street (view east from non-[REDACTED]).

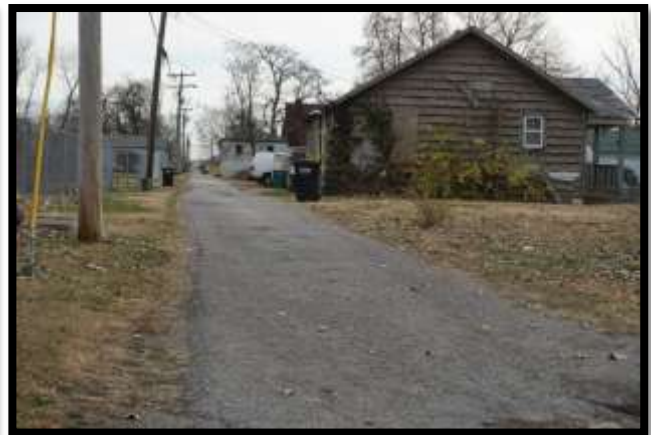
Photograph 12: Alley between Market Street and Logan Street (view east from non-[REDACTED]).

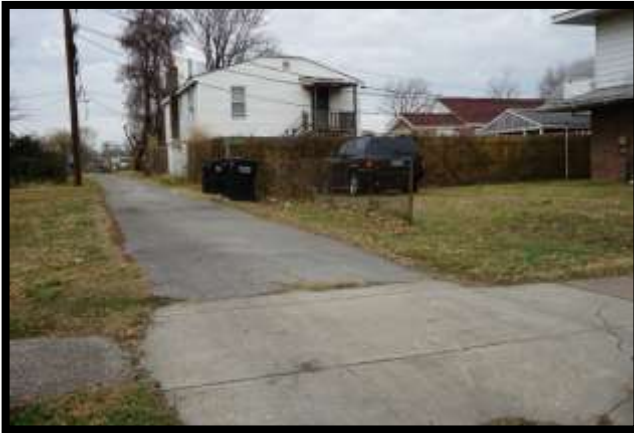
Photograph 13: Alley between Bissell Street and Market Street (view west from Meredocia Street).

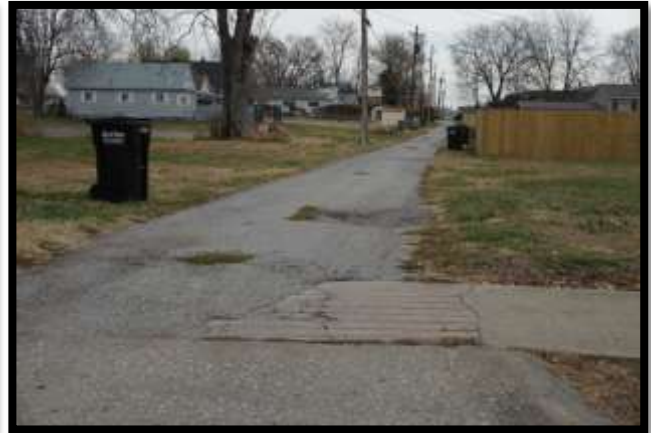
Photograph 14: Alley between Market Street and Logan Street (view east from Meredocia Street).

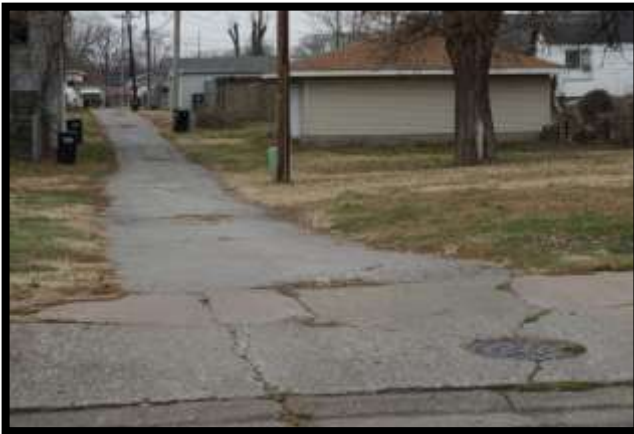
Photograph 15: Alley between Market Street and Logan Street (view west from Meredocia Street).

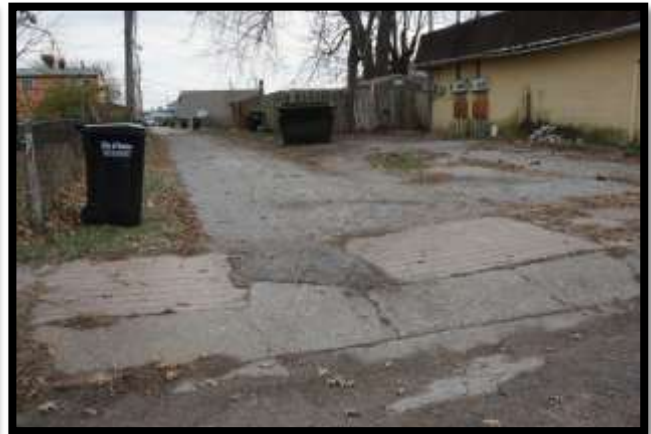
Photograph 16: Alley between Market Street and Logan Street (view east from Selb Street).

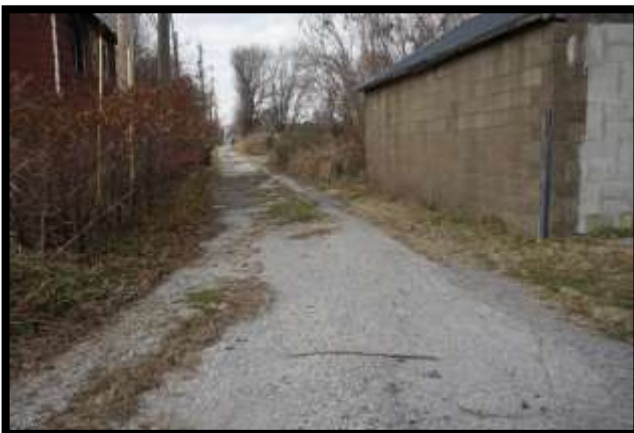
Photograph 17: Alley between Calhoun Street and Douglas Street (view west from Line Alley); several holes have been filled with asphalt since June 2012 inspection.

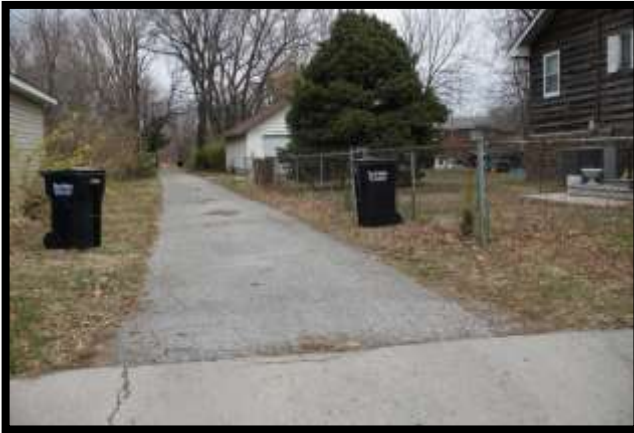
Photograph 19: Alley between Allen Street and Rogan Street (view north from Allen Street).

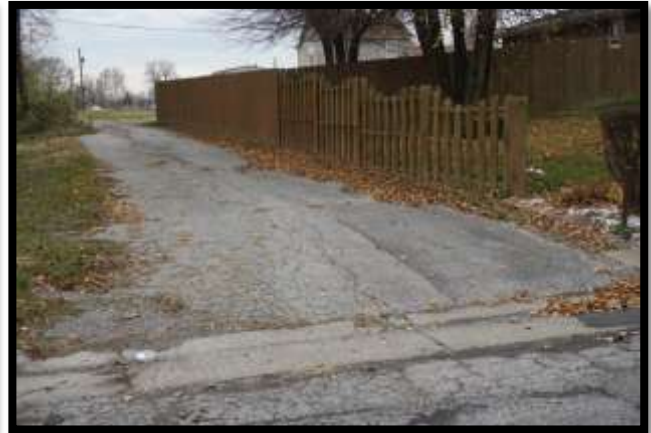
Photograph 20: Alley between Baucum Street and West 3rd Street (view south from Madison Street and College Street).

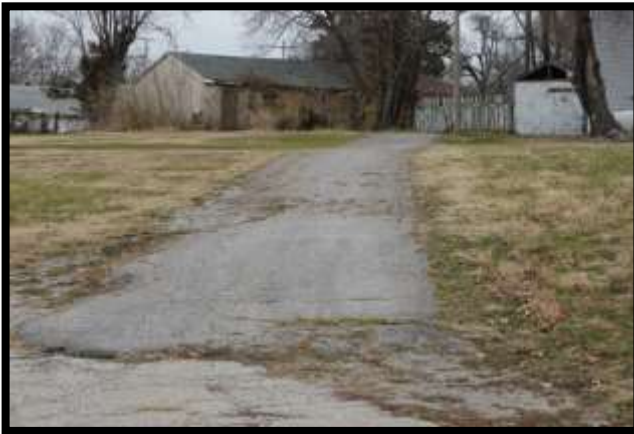
Photograph 21: Alley on Jackson Street (between 3rd Street and Baucum Street).

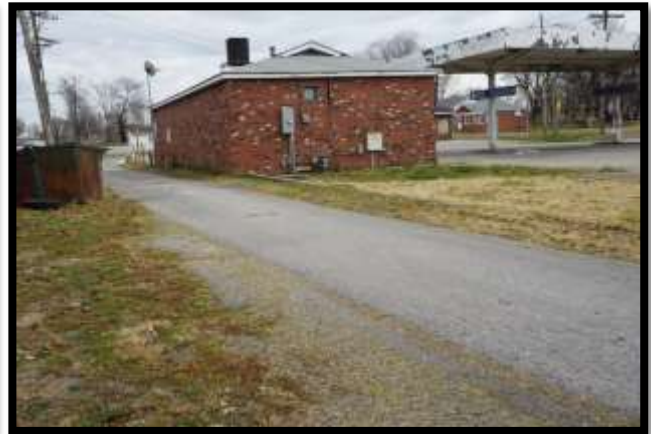
Photograph 22: Alley between 4th Street, Broadway, and Lincoln Avenue.

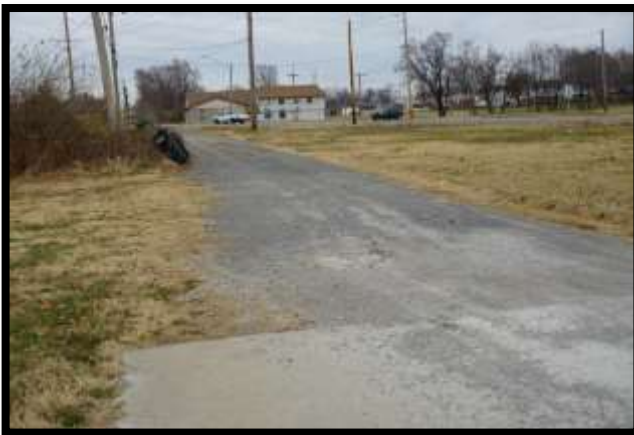
Photograph 23: Alley (gravel) between 3rd Street and 4th Street (view north from Abbott).

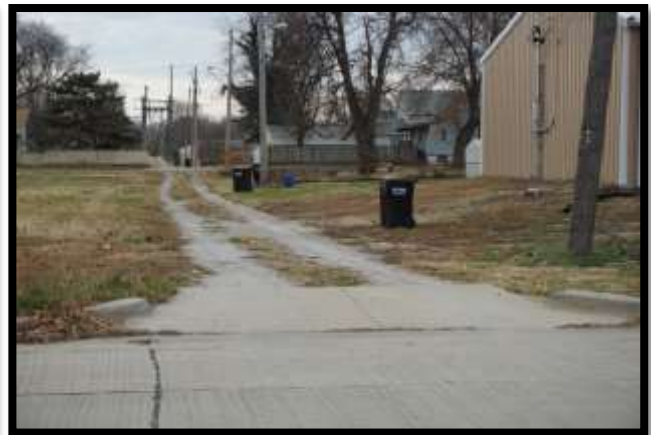
Photograph 24: Alley between 3rd Street and 4th Street (view south from Granville).

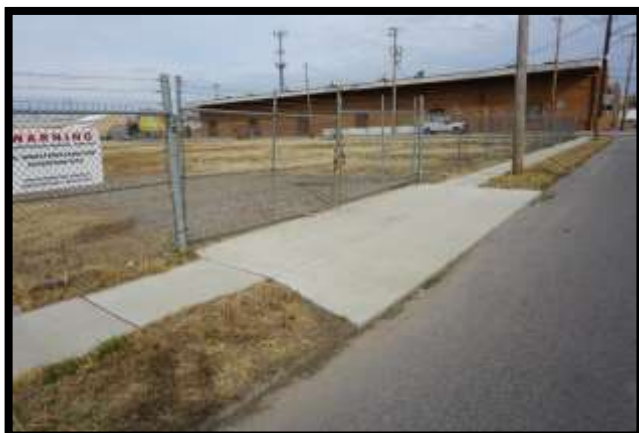
Photograph 1: Entrance to **non-responsive** property along State Street.

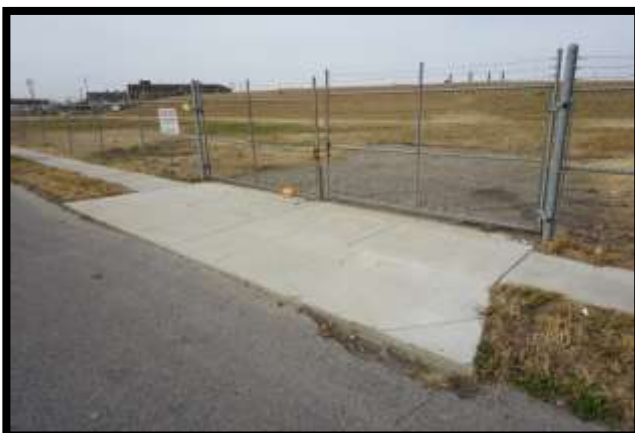
Photograph 2: Entrance to **non-responsive** property along State Street.

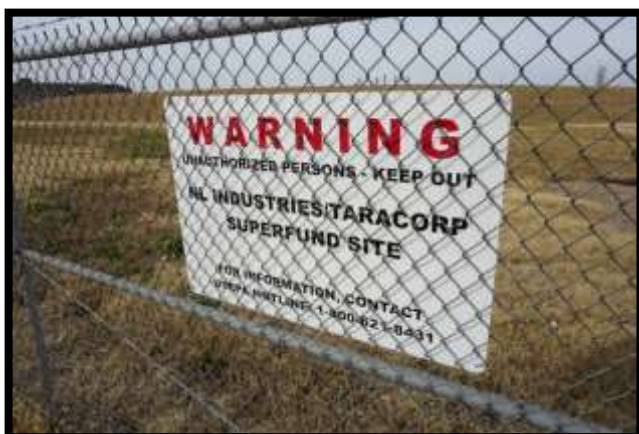
Photograph 3: Warning sign at front gate along State Street.

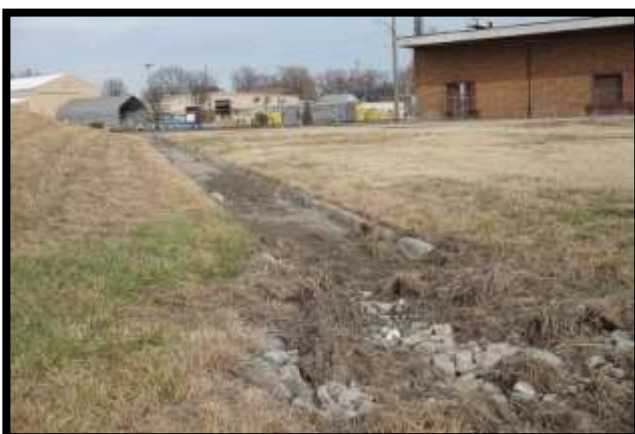
Photograph 4: Concrete drainage swale, east side of Taracorp pile (view north).

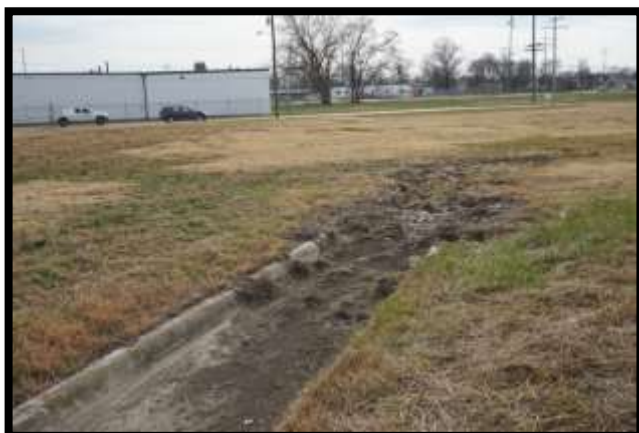
Photograph 5: End of concrete drainage swale, east side of Taracorp pile.

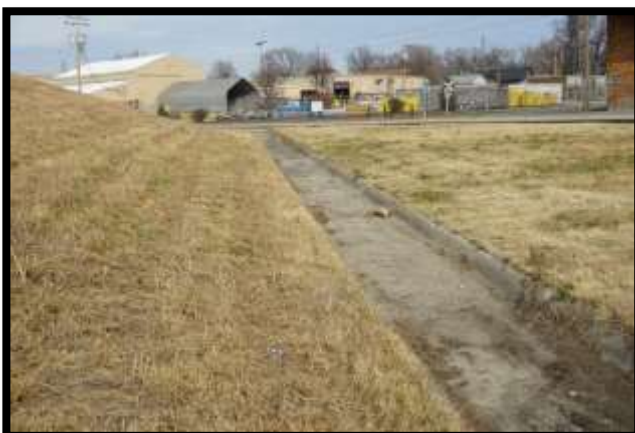
Photograph 6: Concrete drainage swale, east side of Taracorp pile (view north).

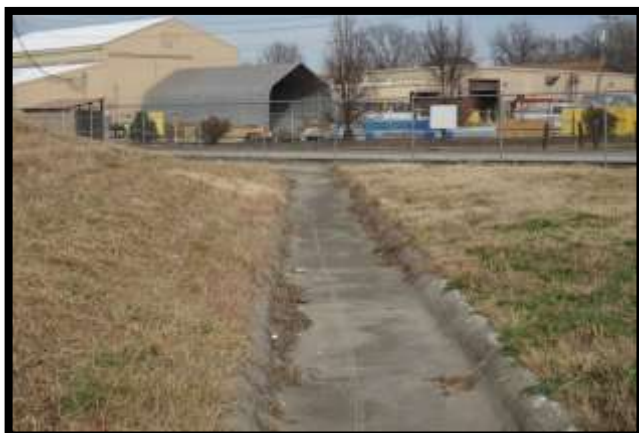
Photograph 7: Concrete drainage swale, east side of Taracorp pile (view north).

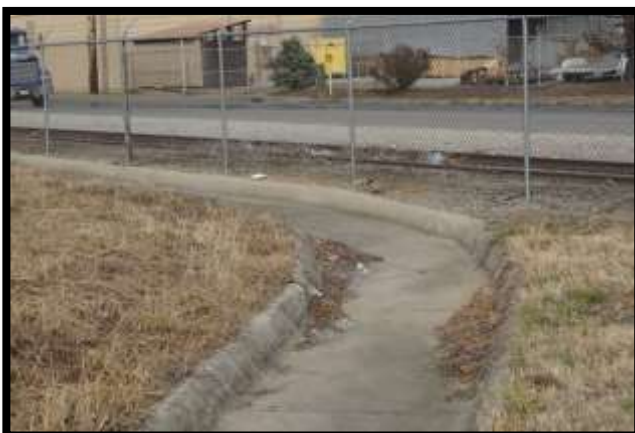
Photograph 8: Concrete drainage swale, east side of Taracorp pile (view north).

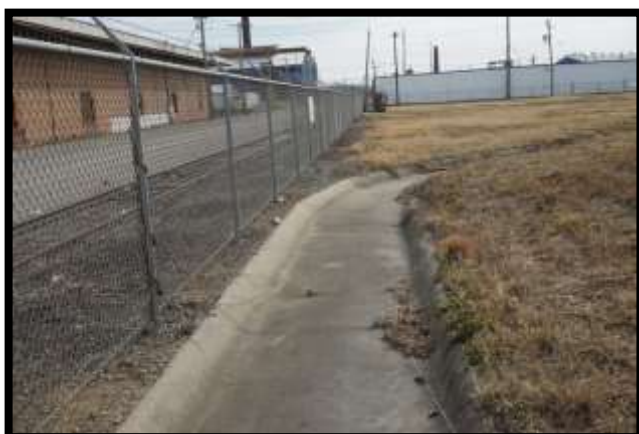
Photograph 9: Concrete drainage swale, north side of Taracorp pile (view southeast).

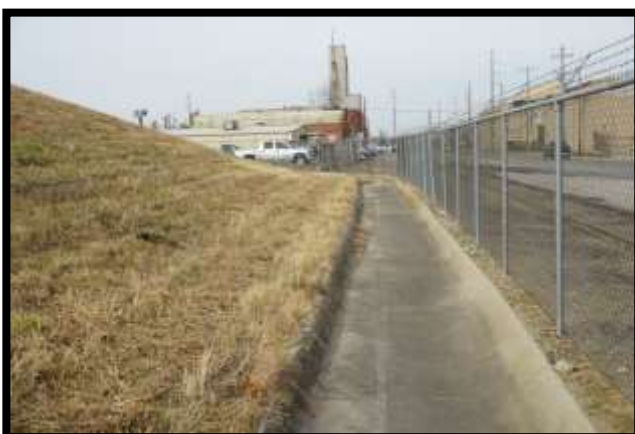
Photograph 10: Concrete drainage swale, fence, and vegetation; north side of Taracorp pile along 16th Street (view northwest).

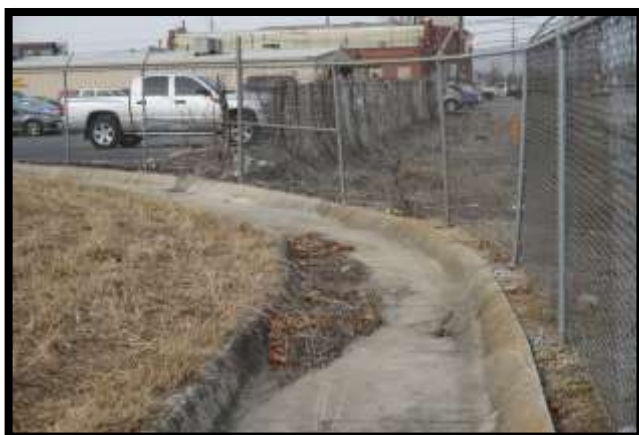
Photograph 11: Concrete drainage swale, fence, and vegetation; north side of Taracorp pile along 16th Street (view northwest).

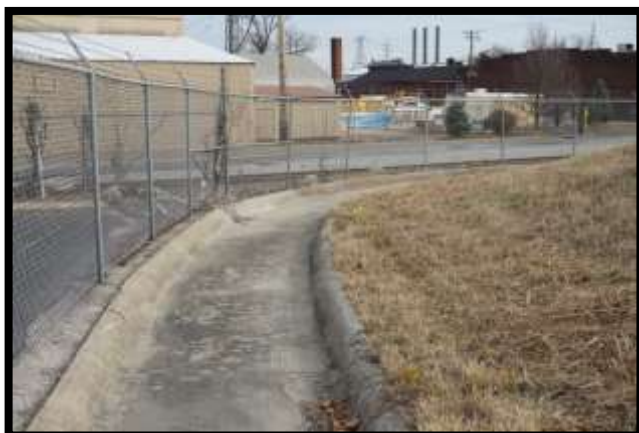
Photograph 13: Concrete drainage swale and vegetation, northwestern side of Taracorp pile (view northeast)

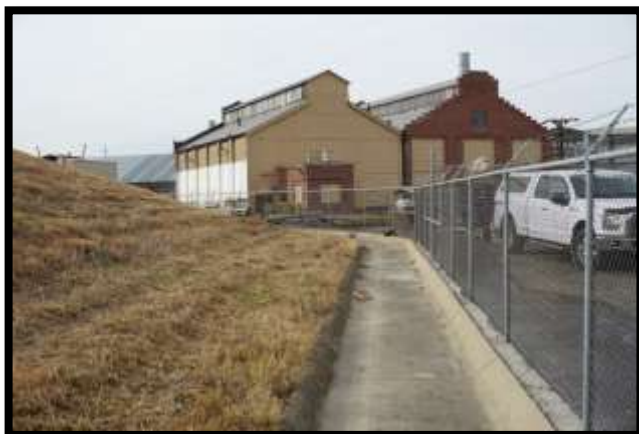
Photograph 15: Concrete drainage swale, fence, and vegetation along northwestern side of Taracorp pile (view southwest).

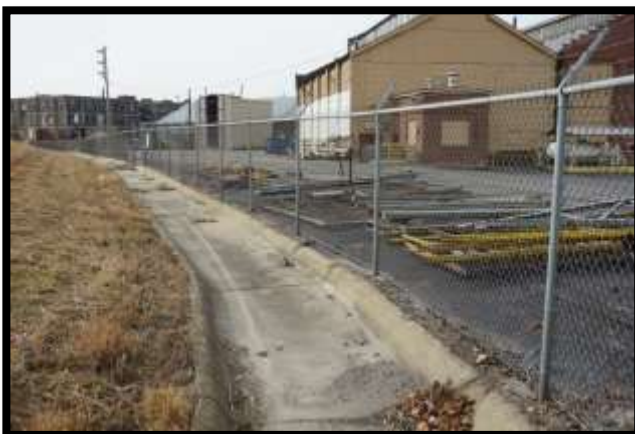
Photograph 16: Concrete drainage swale, fence, and vegetation along northwestern side of Taracorp pile (view southwest).

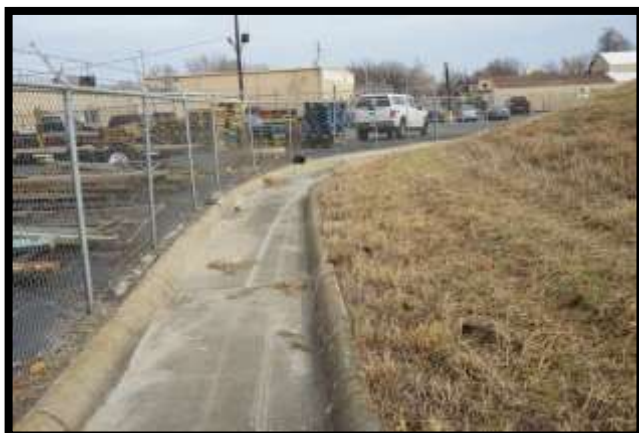
Photograph 19: Concrete drainage swale, vegetation along northwestern side of Taracorp pile (view north/northeast).

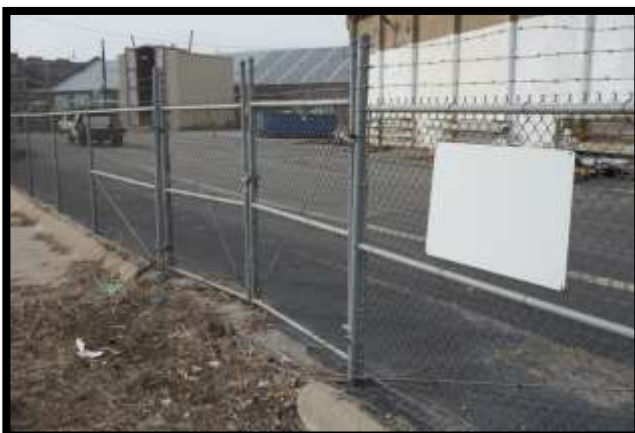
Photograph 20: Fence, warning sign, and gate, western side of Taracorp pile (view southwest).

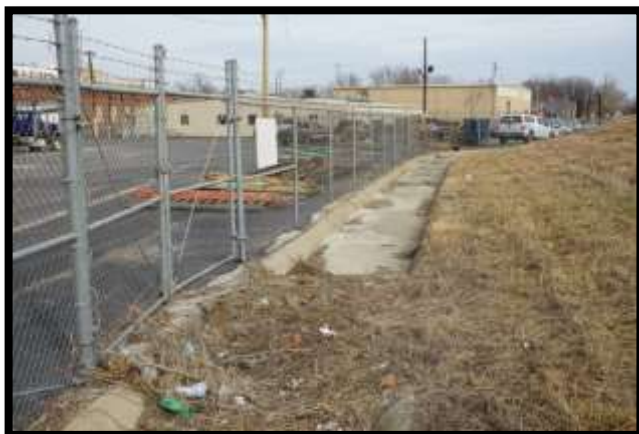
Photograph 21: Vegetation near base of west side of Taracorp pile (view northeast).

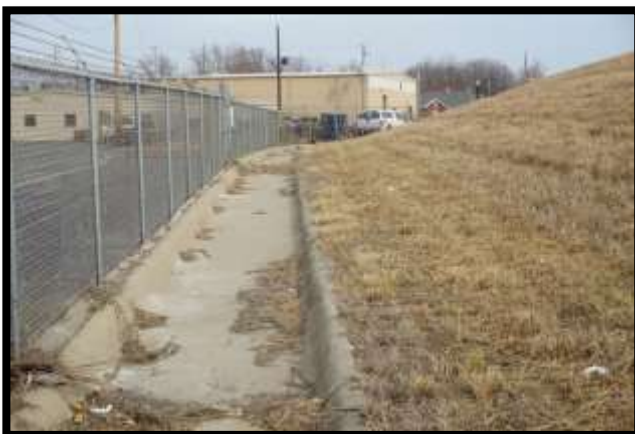
Photograph 22: Vegetation near base of western side of Taracorp pile (view north).

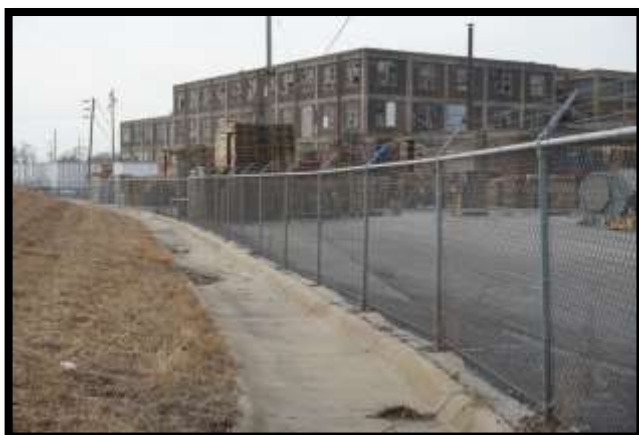
Photograph 23: Concrete drainage swale and vegetation near base of western side of Taracorp pile (view south).

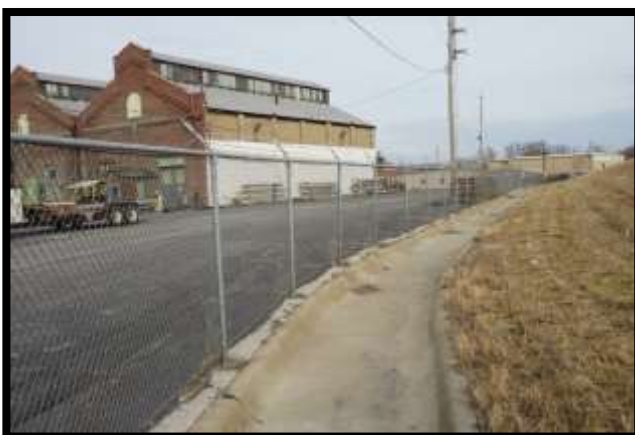
Photograph 24: Vegetation along western side of Taracorp pile (view north).

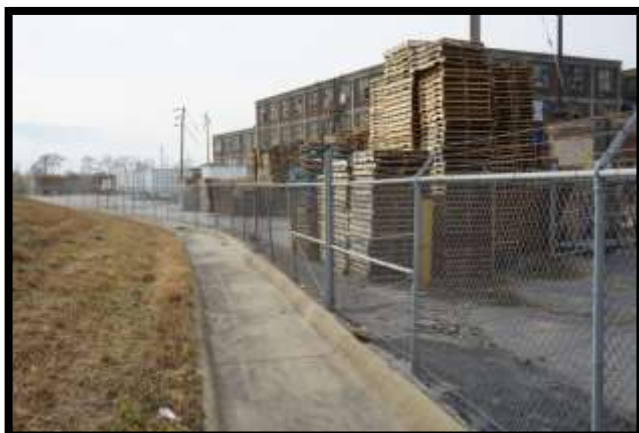
Photograph 25: Concrete drainage swale and vegetation near base of western side of Taracorp pile (view south).

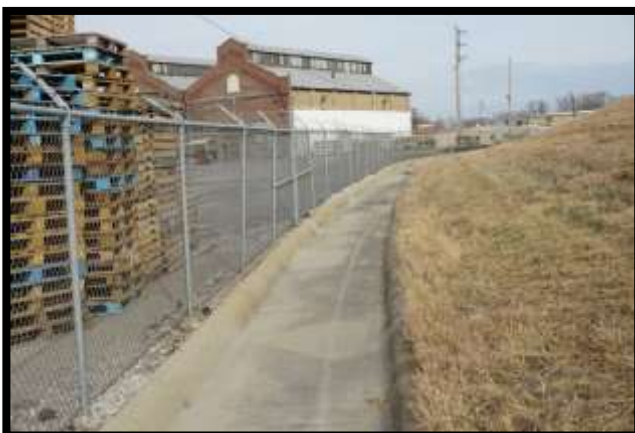
Photograph 26: Concrete drainage swale and vegetation near base of western side of Taracorp pile (view north).

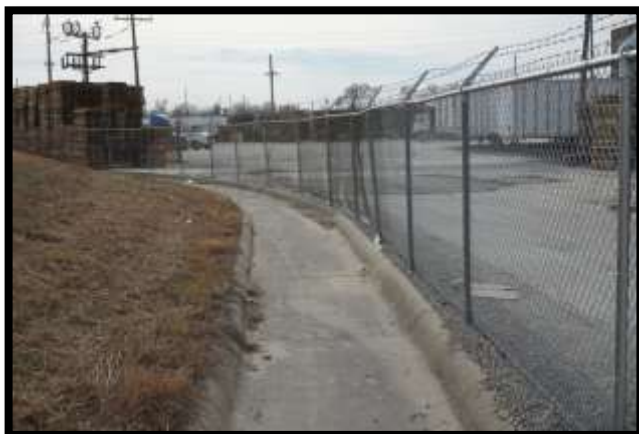
Photograph 27: Concrete drainage swale and vegetation near base of western side of Taracorp pile (view south).
